This is a copy of a drawing included with the model S-600 Lee Flour Mill. The original was a blueprint or Ozalid copy that faded badly near the left and right sides. So some guesses were made in the block of text at the bottom

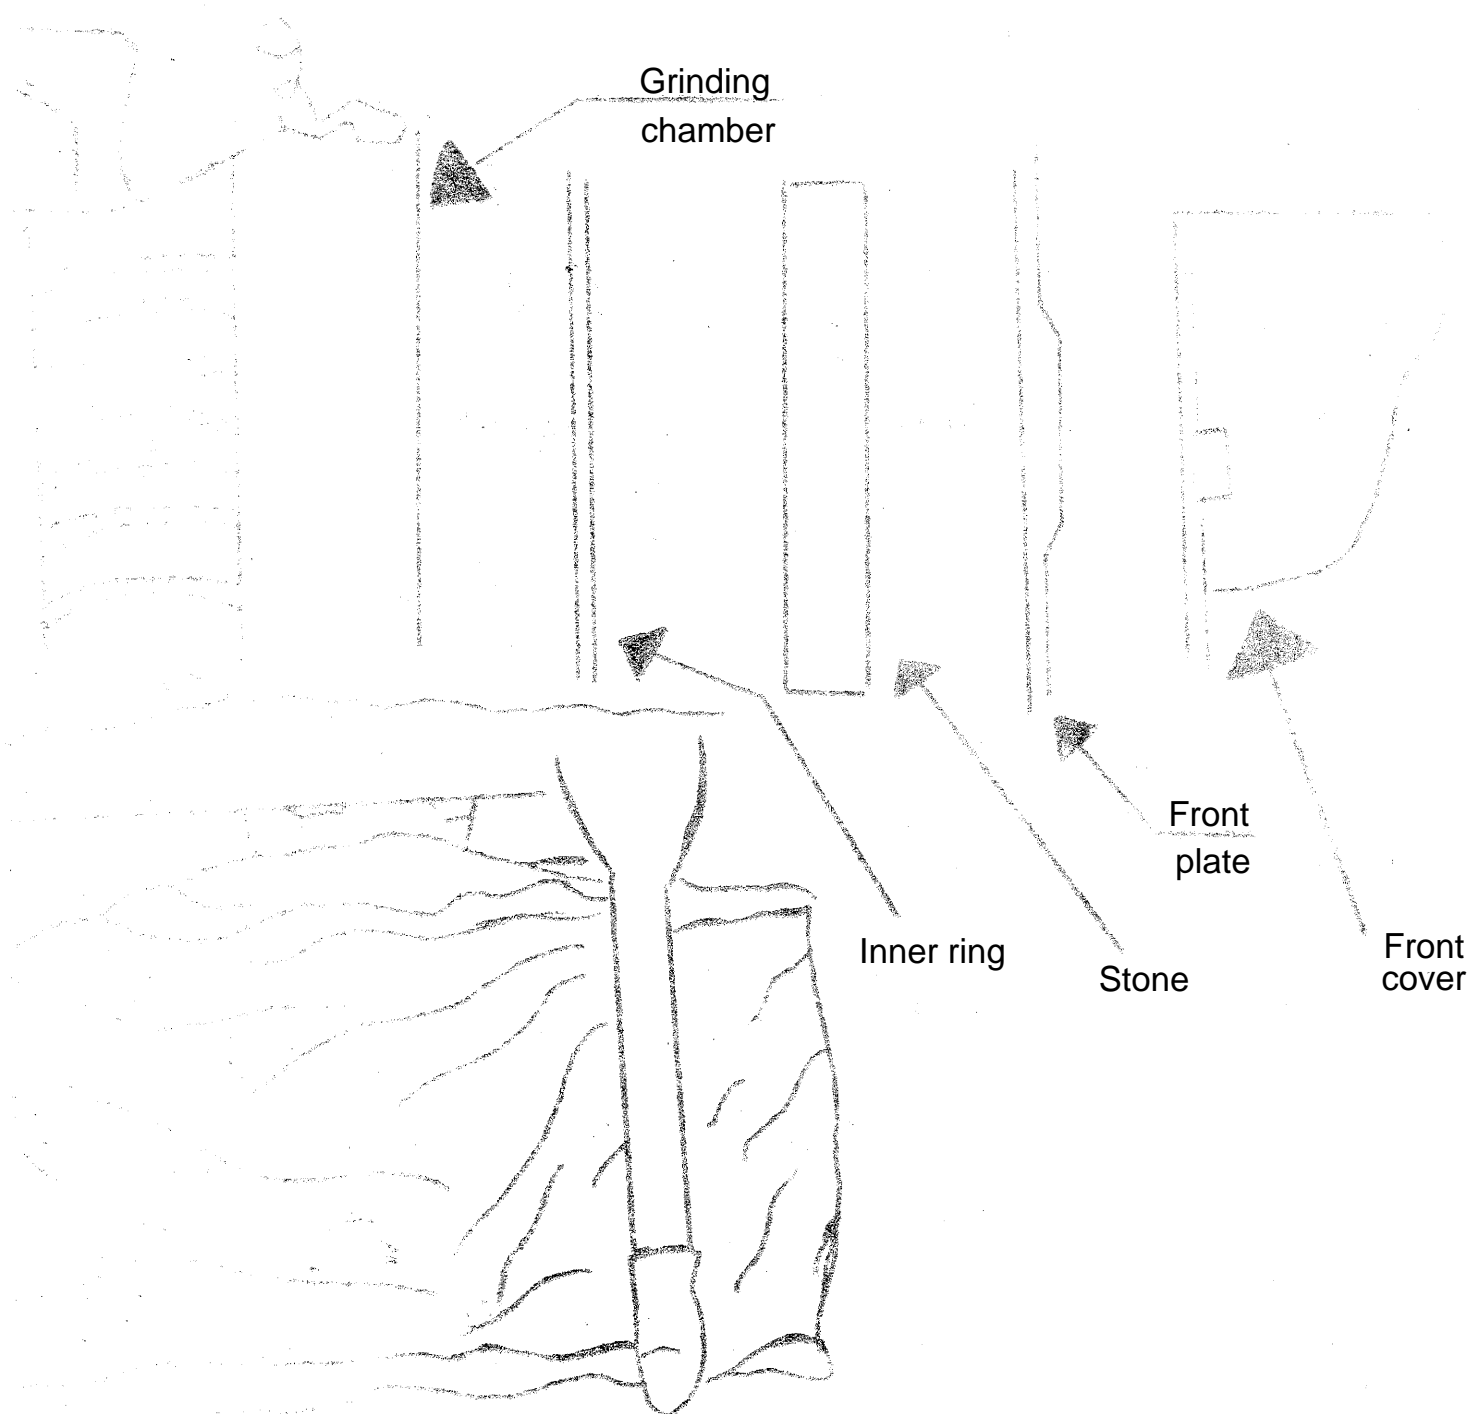
Recent product inspection has shown that grain, flour or some other foreign material may become lodged between the grinding stone and the grinding housing or behind the inner ring which is located behind the stone. This condition will cause the grinding stone to be set away from the inner ring and allow grain to flow too rapidly into the grinding chamber which will overload the rotor. This will cause the mill to run slowly or to stop completely. To remedy this condition it is necessary to remove the stone and inner ring and to clean the housing so that the stone is seated properly.

If the stone is tight, it may be removed by tapping lightly with a wood block. The inner ring may be removed by finger pressure applied through the flour outlet.
